ST PANCRAS CHAMBERS

HISTORY IN THE MAKING

After nearly a century of decay, St Pancras Chambers has been restored to its former glory. Critical acclaim from the world's press is testimony to the success of the work undertaken by many specialist tradesmen to bring this extraordinary building back to life. This volume is a celebration of the construction skills involved in the restoration at the St Pancras Renaissance Hotel – a £100m+ scheme for our client Manhattan Loft Corporation.

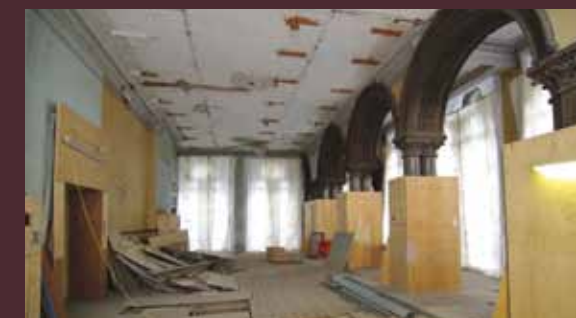
Right: The Ladies' Smoking Room, before restoration.

Both the Ladies' Smoking Room and Gilbert Scott hotel suite had ornate ceilings, which formed the bulk of the work for Angel Interiors. Work to reinstate the original, 1870s decoration on the ceilings in both rooms followed a similar pattern: reveal; colour matching and tracing; base decoration and forms and finally intricate and delicate brush work, including gilding.

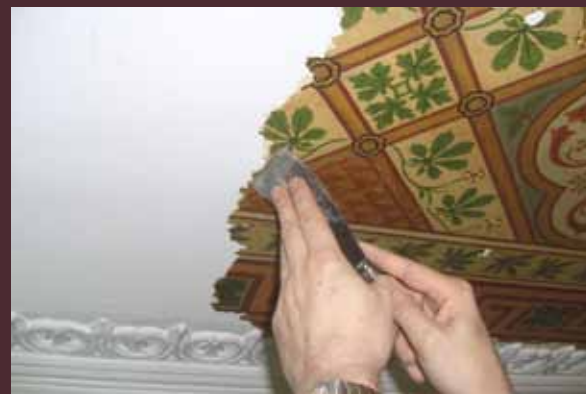
Right: Every scrap of overpainting was removed with a scalpel blade to reveal the entirety of the original scheme. Reveal of the Ladies' Smoking Room ceiling took 100 man days.

The original ceilings had been covered in white emulsion and various other paints. Peeling paint revealed earlier layers and timber blocks had been screwed onto the surface in places to strengthen areas of friable plaster. To establish the scheme and colours, every scrap of overpainting was first removed with a scalpel blade.

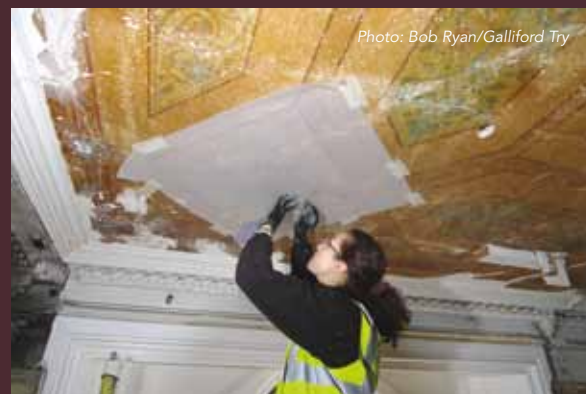
Bottom Right: Tracing the design in the Ladies' Smoking Room.

Far Right: Paints are hand mixed to match all the colours in the scheme and painted on numbered cards for easy reference and to avoid confusion. In the Ladies' Smoking Room scheme, 30 different colours were identified.

To match the colours exactly, an area was then cleaned of its yellowed varnish using conservation methods. Paints were hand mixed to match all the colours in the scheme and then signed off by RHWL's project architect.

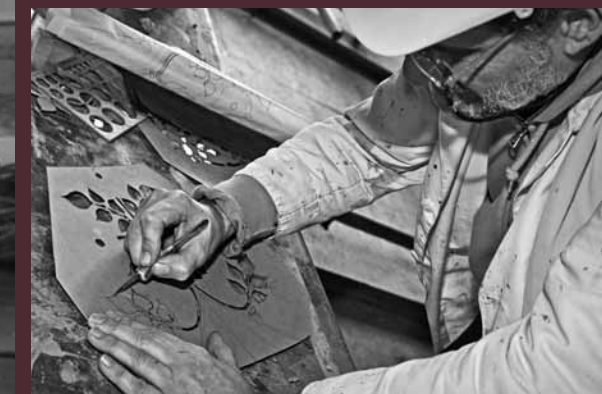
Left: Each traced design was transferred onto waxed paper and cut out with a scalpel. This forms a 'master stencil' which is used to create the working stencils. Using the same master ensures that the stencils are identical. The working stencils are carefully sealed so that each can be used up to 60 times – another factor in ensuring accuracy. "The work has to look accurate from the top of the birdcage scaffold, not just from the ground," says Gary Butcher.

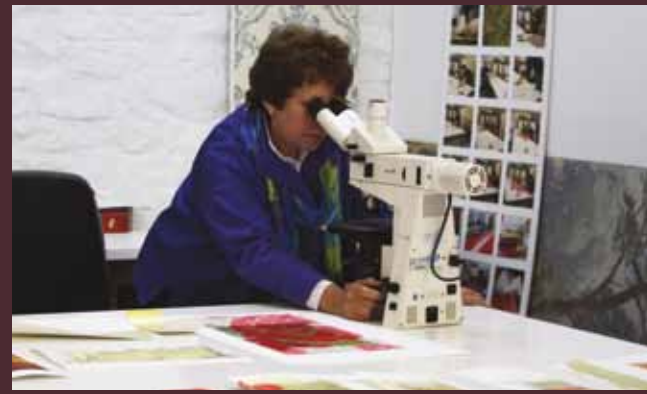
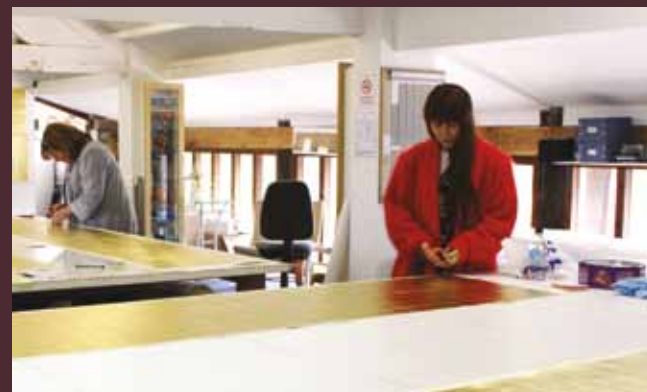
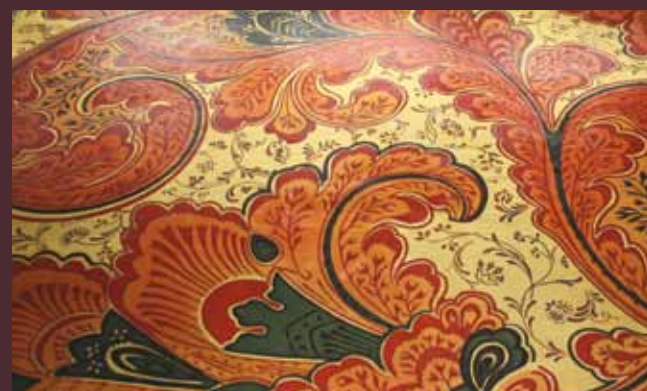
Top: Analysis and research
Middle: Gilding the paper with 22 carat gold leaf
Bottom: Section of final printed design

- Examination under 10x and 60x showed the use of a ground preparation layer beneath the gold, probably a gold size rather than glue, as would be expected.
- The colours were all applied thinly in varnish glazes.
- The paper was stained with both Herzberg and Phloroglucinol, indicating a mixture of fine cotton and lignin containing fibres.
- The paste used to hang the wallpaper contained starch.

- The paper was sized using an animal glue and percentage and drying times were tested and proofed.
- The gold was applied, leaf-by-leaf onto the sized paper. Both loose and transfer leaf were tested for accuracy and ease of application. Three different types of gold were used.

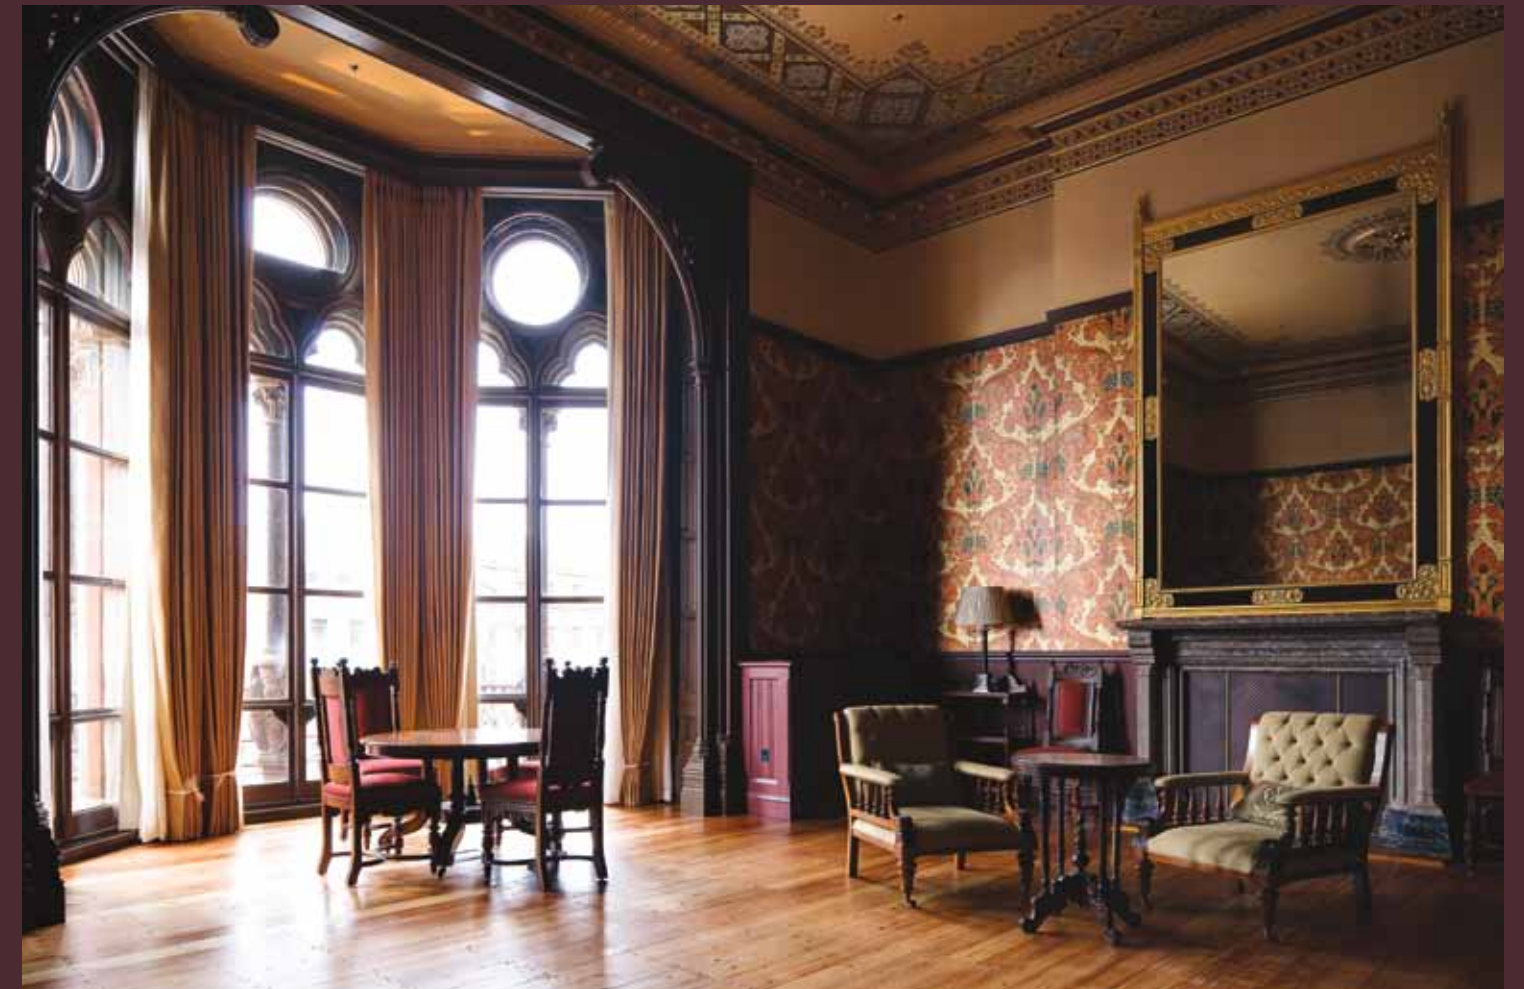
Above & right: The finished wallpaper in the Gilbert Scott Hotel Suite. Photos: Tim Crocker

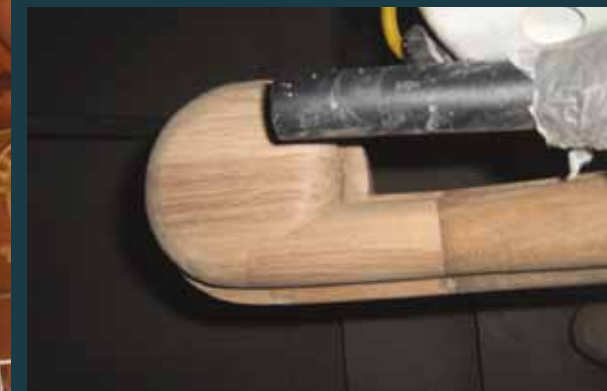
Far left: False gallows brackets (red) in The Booking Office Bar, the former ticket office. These were manufactured to match the existing building fabric.

Left: Heritage joinery work included refurbishment of original staircases, balustrades and handrails. A lot of hand carving was required.

Items of original joinery were disassembled, cleaned and re-glued – any missing or damaged sections being replicated by specialist craftsmen. Heritage joinery work required a lot of hand carving and included the refurbishment of the mahogany panelling in The Booking Office Bar and refurbishment of original staircases, balustrades and handrails.

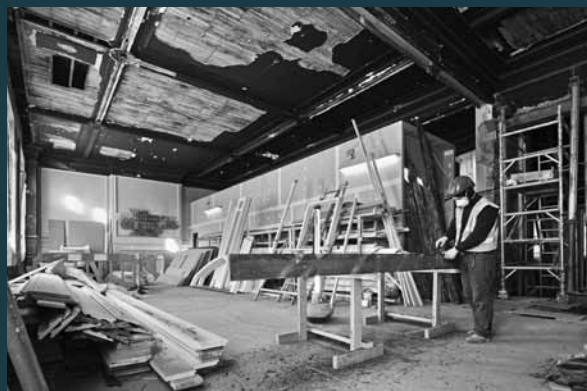
Left: The heritage floorboards – up to 6m in length – were de-nailed and planed on site, before being replaced. This task took six months!

The existing floor had to be regularised and reinstalled, but ideally 'heritage' timber should not leave the site. So, with very limited space, Atlantic set up a joinery workshop at St Pancras to process the floorboards. The Presidential Suite was chosen for this, but first it had to be fire and soundproofed. The floorboards – up to 6m in length – had to be carried down narrow corridors and turned into rooms. Each had to be de-nailed, using hand-held metal detectors, planed and replaced. This task took six months!

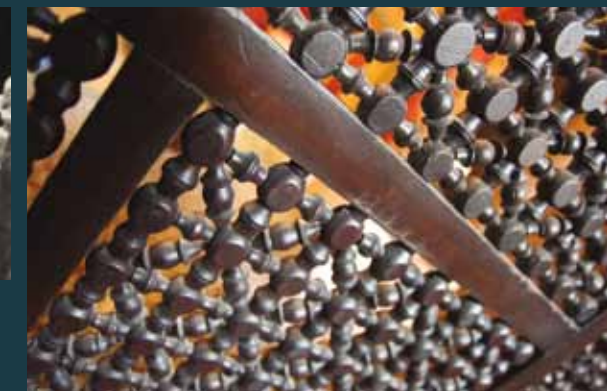
Left: Restoration of the mahogany Moroccan balustrade at the bottom of the Grand Staircase was a major challenge. It had to be taken apart and the damaged or missing individual pieces replicated on a lathe before re-assembly. This was done off-site in the Leicester workshop.

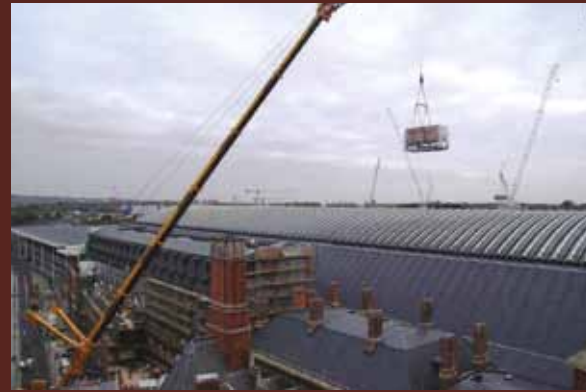
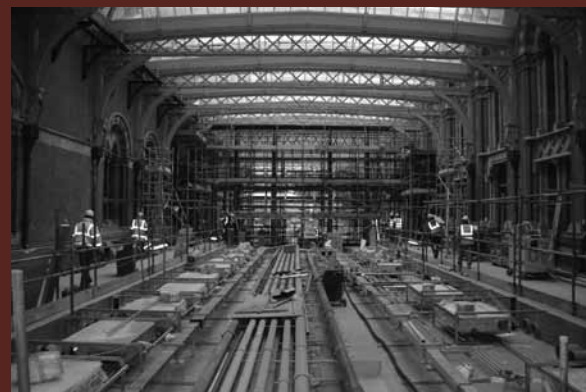
Above: Most of the main services for the hotel and private apartments run under the old taxi-rank, now the hotel lobby and reception.

Above: Logistics were challenging. Equipment for one of the main plant rooms being lifted with a 500 tonne crane into the roof-space of Barlow House. A section of the roof had to be removed, so that chillers, pumps and air-handling units could be installed in 'kit' form.

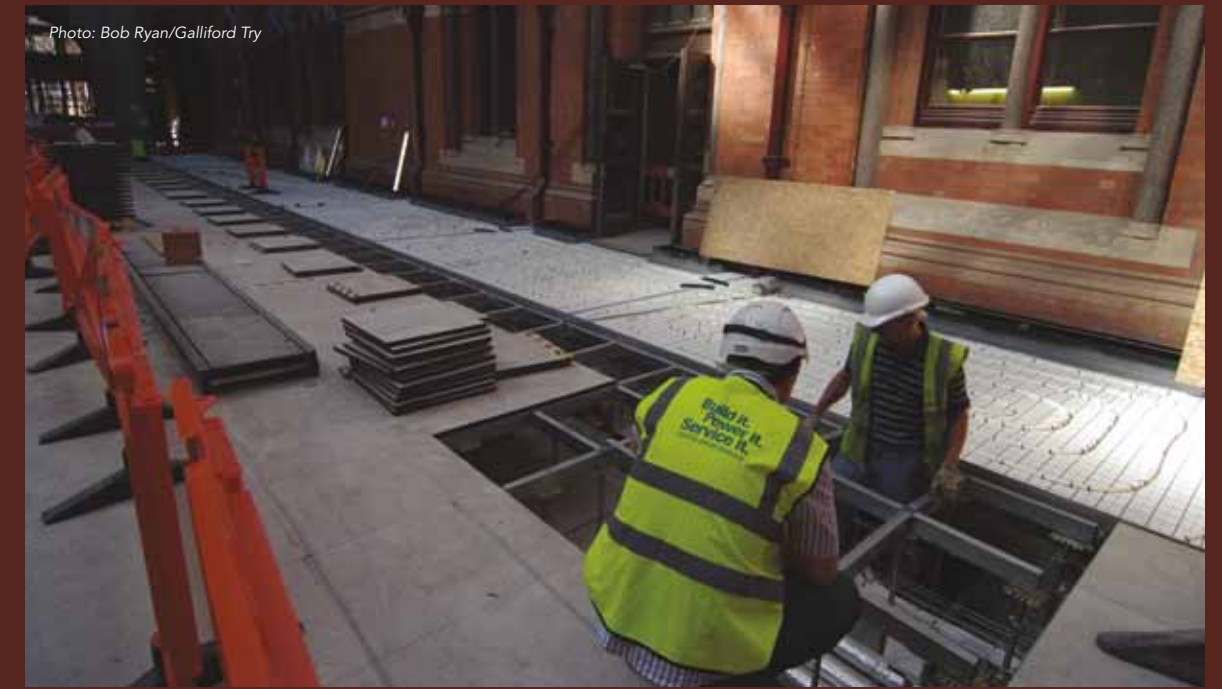
Above: Fitting and assembly of the underfloor heating in the hotel reception.

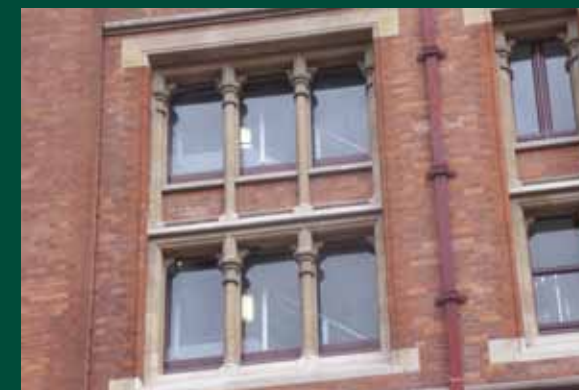
Right: Old, worn windows were updated with high quality modern replacements.

restrictions and how they can be worked alongside building regulations and new energy requirements. However, the building's Grade I status meant certain compromises had to be made. For example, old, worn windows were updated with high quality modern replacements, but the Grade I listing indicated that these replacements should be single, rather than double-glazed.

The windows were all manufactured in hardwood for stability and durability. A micro-porous paint was applied using the in-house spray booth. This finish allows the timber to breathe more naturally, thus prolonging the life of the window. Glass was supplied by a small local company, JTS Glass, who were able to deliver same day replacements to site for broken panes.

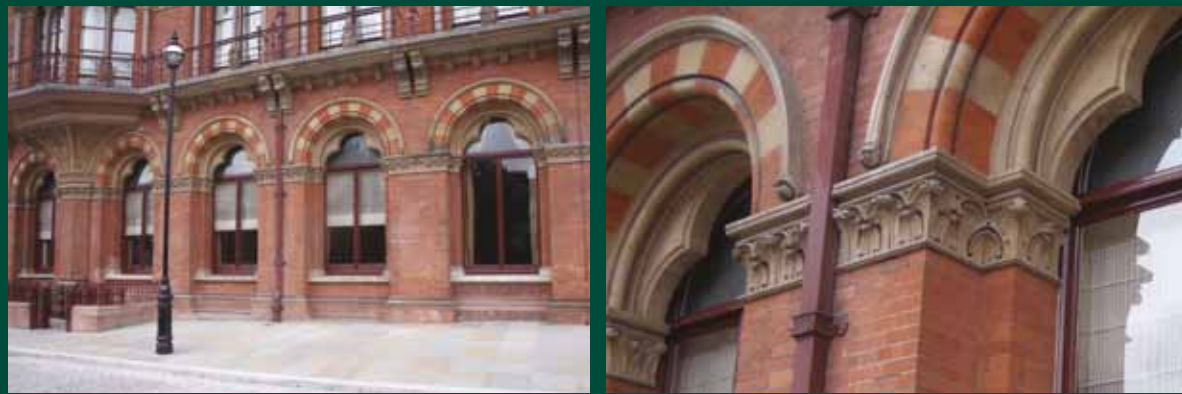
Left: many of the windows had arch tops - such as the large Gothic remakes to the front of the building.

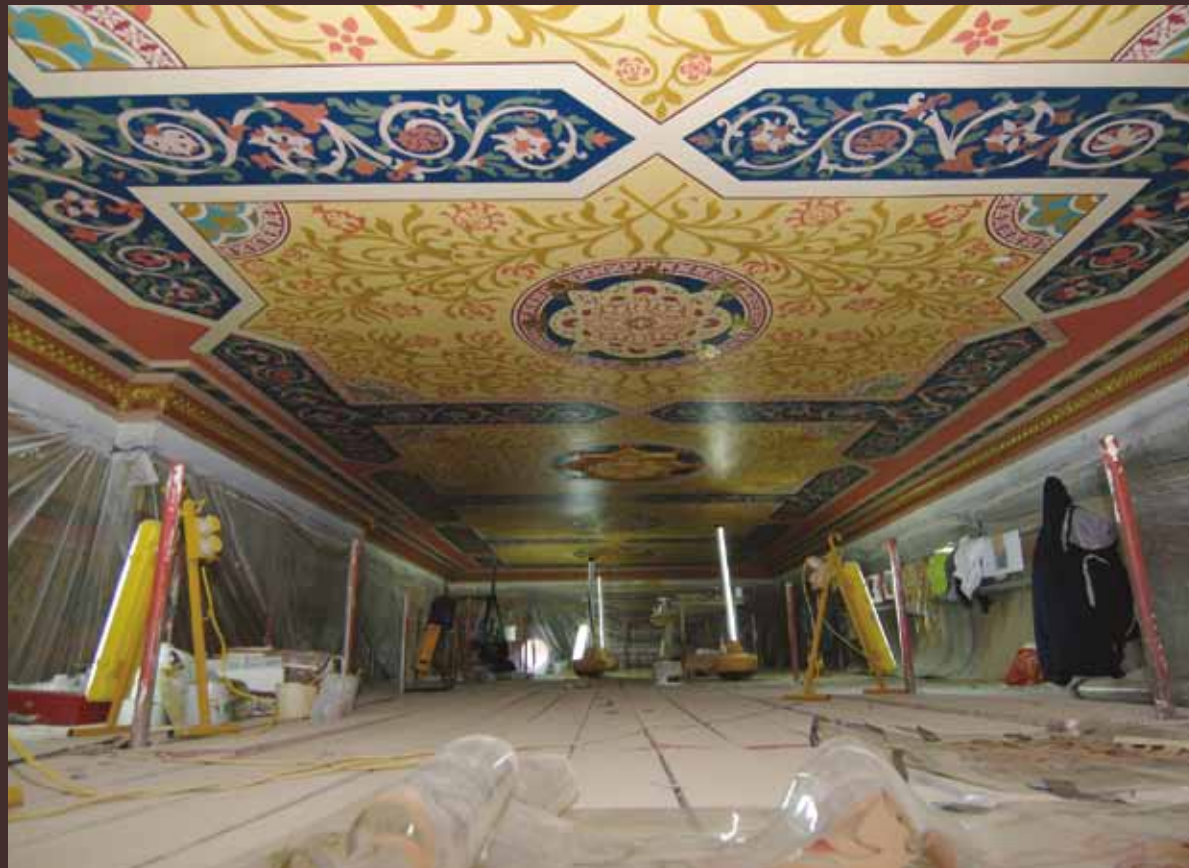
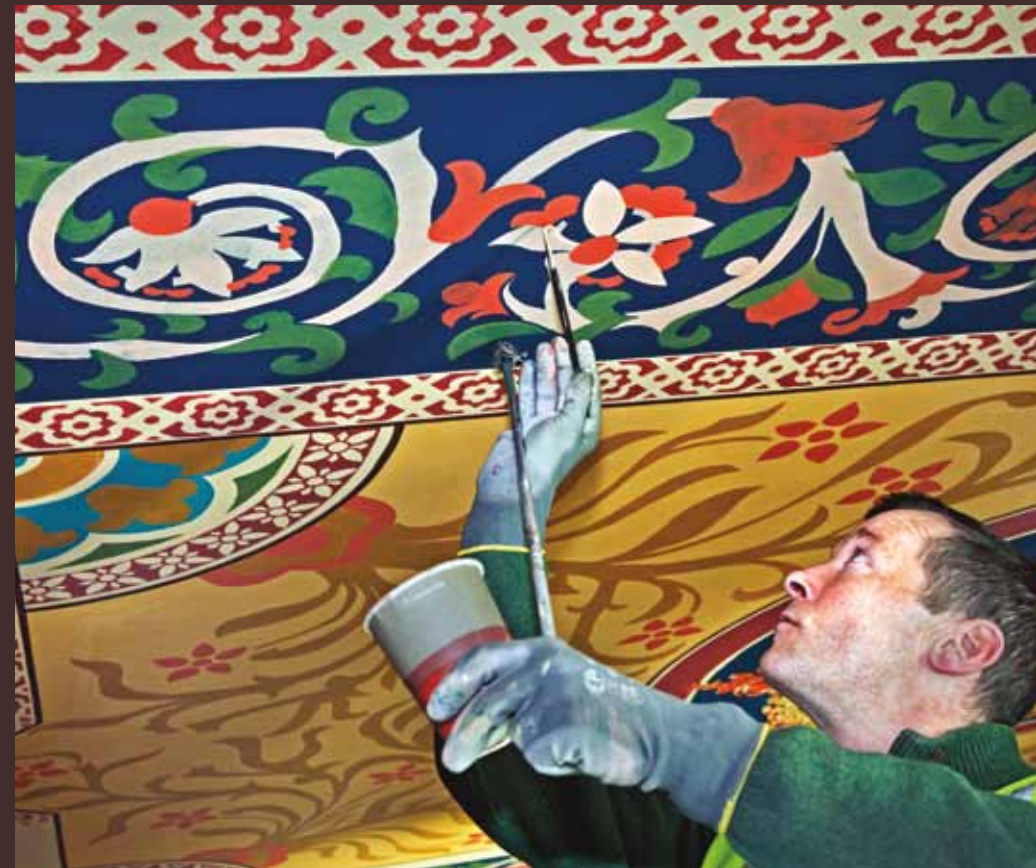
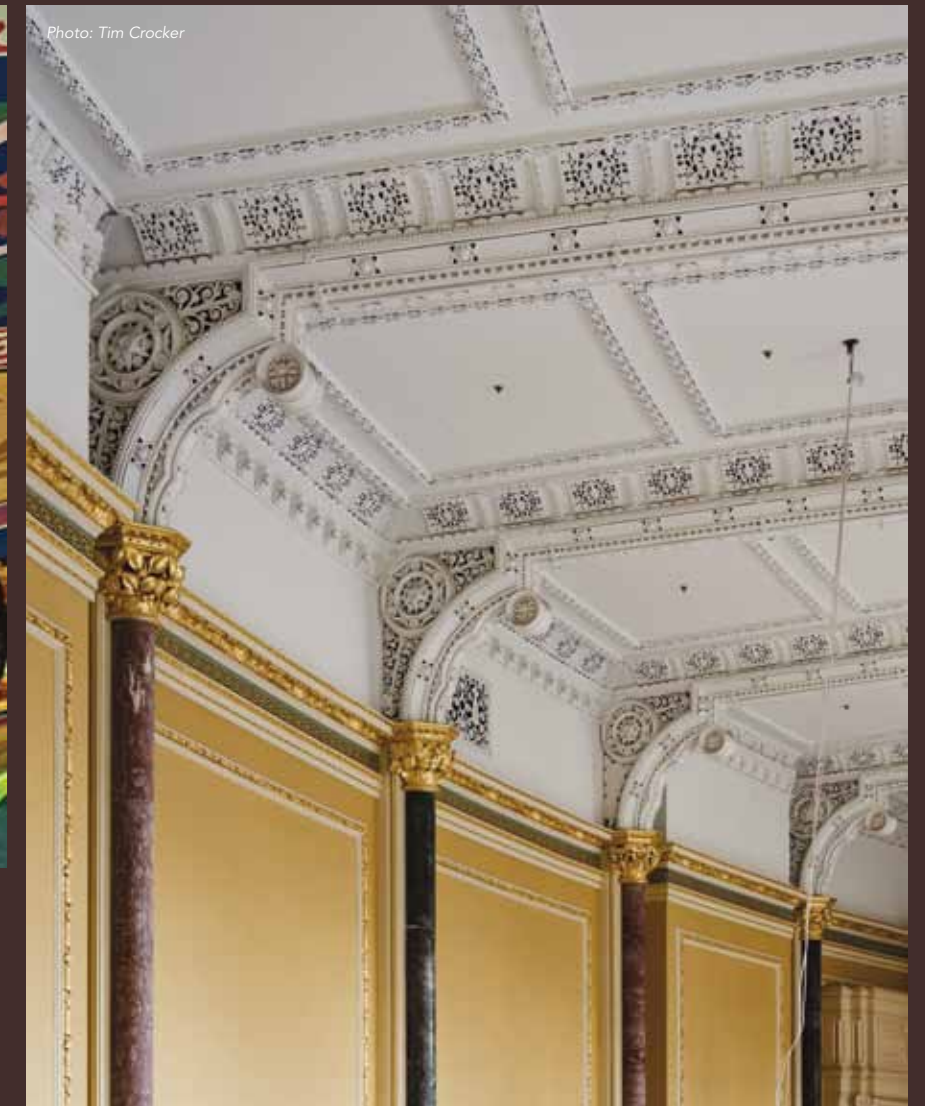
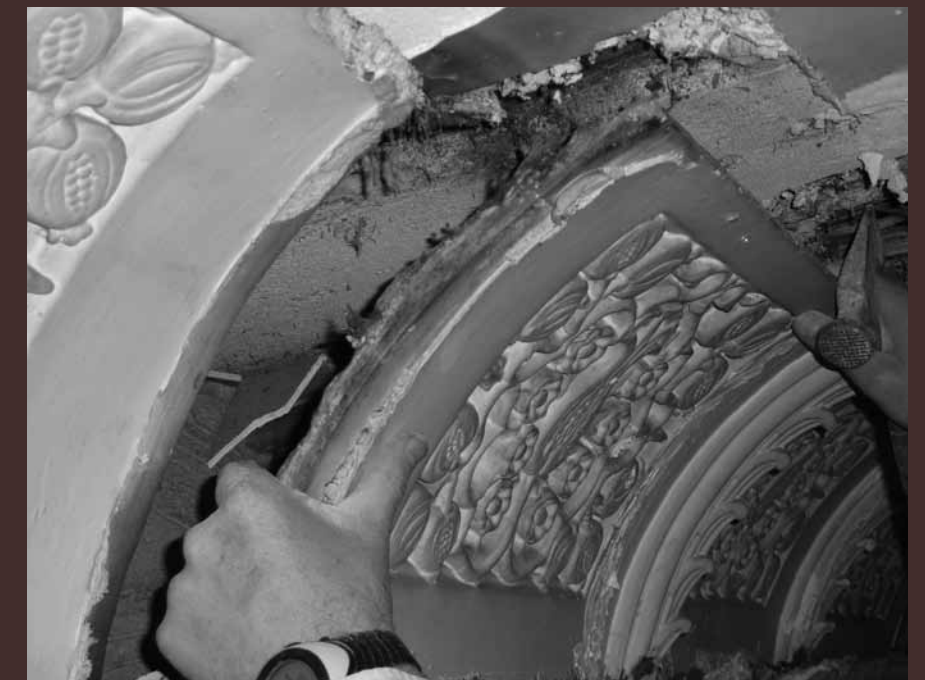
Above & Right: Ceiling restoration in the Gilbert Scott Lounge Bar.

Bottom: Significant plasterwork repairs were undertaken in the Chambers building.

The survey involved assessing the nature and extent of damage to the internal historic plasterwork in over 700 rooms and adjoining staircases and corridors – and producing detailed specifications for tender purposes. Planning and listing regulations meant that as much original material as possible had to be retained, so all defects requiring repair were recorded: plaster losses, fractures, holes and unstable areas. This was all quantified and the repair methods specified.

Hirst Conservation then specified the exact mortar mixes for the plastering works. Careful analysis of the original plaster ensured that the new material would be compatible with the old. This is particularly important for any patch repairs. As the work progressed, mortar mixes were sampled regularly and analysed in Hirst’s laboratory to check for consistency.

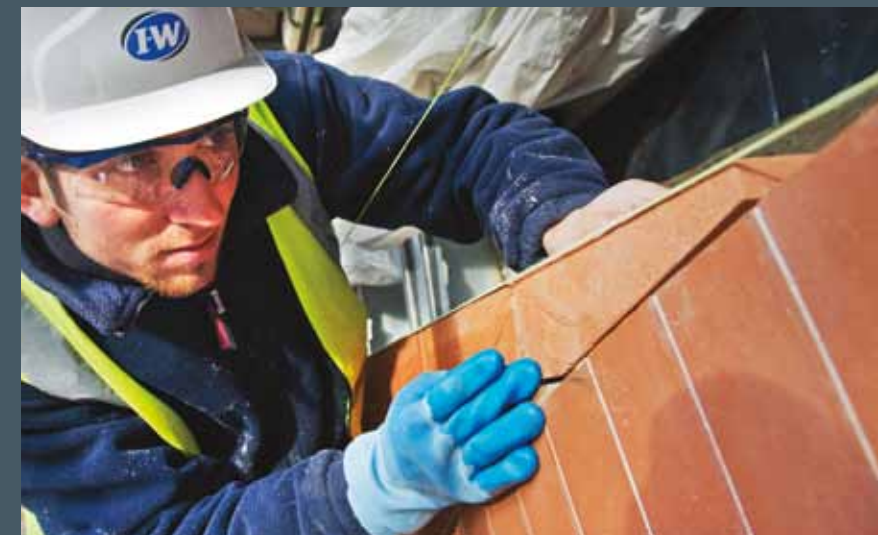
Top: For the hotel's new West Wing, 172,000 Charnwood handmade facing bricks were cut to height by Bulmer Brick. Behind these are 60,000 Charnwood handmade standard imperial backing bricks.

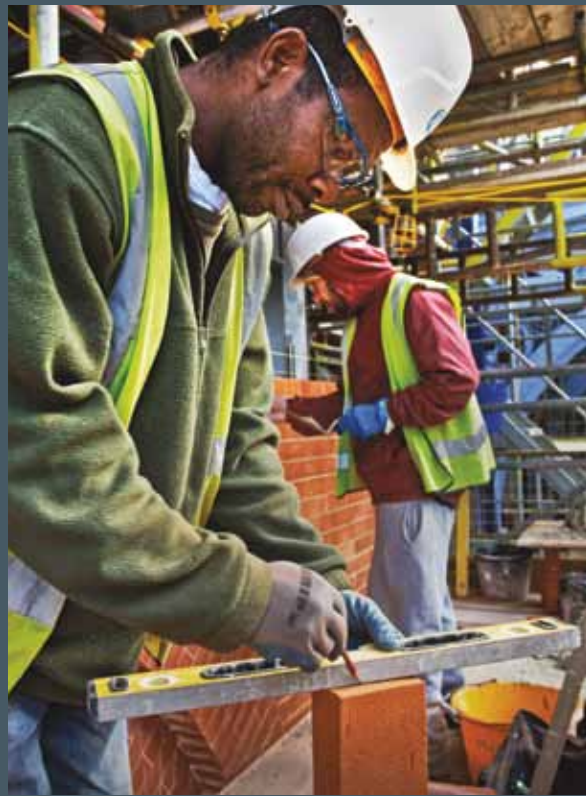
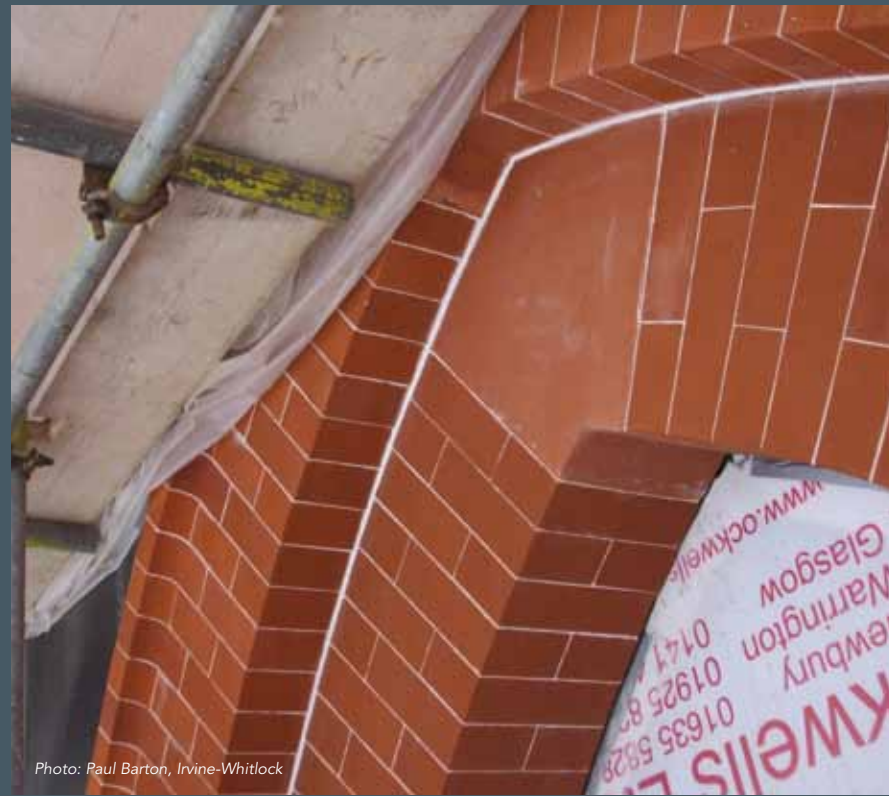
Above & left: On the Gothic arches, the joints are only 2mm wide and for these, a sand-free lime putty was used.

Great care was taken to match the existing 5mm jointing on the facing bricks: Irvine-Whitlock's bricklayers made up hardwood jointers to exactly the right width. On the Gothic arches, the joints were even finer – only 2mm – and for these, a sand-free lime putty was used.

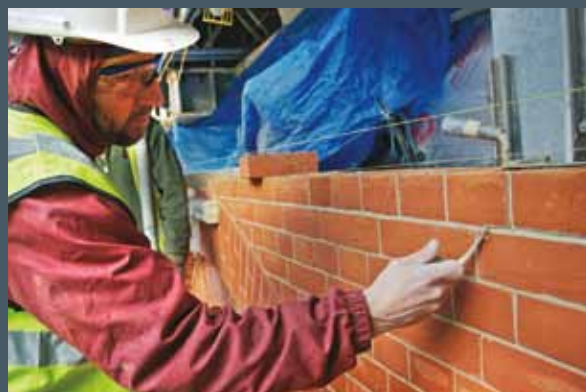
Above left & left: Some of the red rubber bricks had to be cut exactly to size on site. Great care was taken to match the existing 5mm jointing on the facing bricks. Hardwood jointers were made up to ensure accuracy.

Over 80 trial mortar mixes had been made up by Lime Technology before one of the correct colour and consistency was found. On site, the pre-mixed dry mortar powder was stored in a 29 tonne silo and mixed as required: this reduced waste. When bricklaying work started on the station, the bricks were found to absorb the water from the lime mortar too quickly. Soaking the bricks before laying gave more time to lay the bricks and shape the joints before the mortar became unworkable.

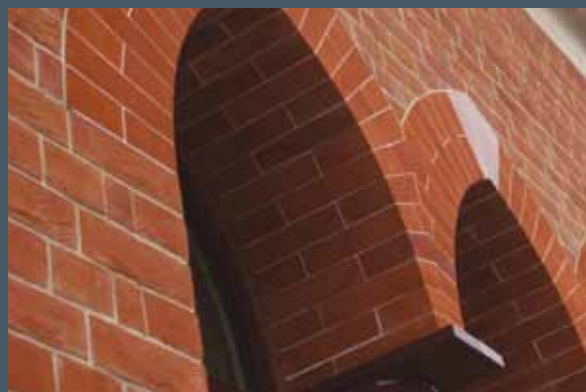
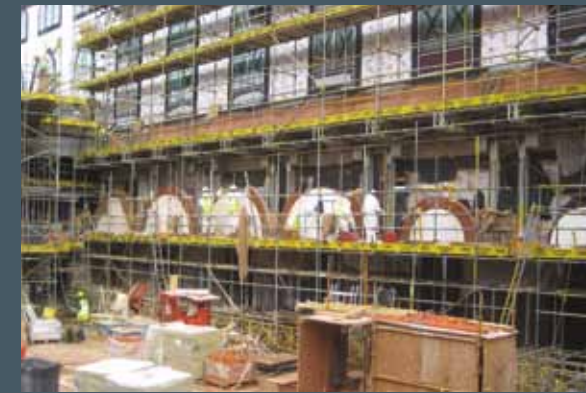
Above (both): Arches were built over polystyrene forms and these were re-used.

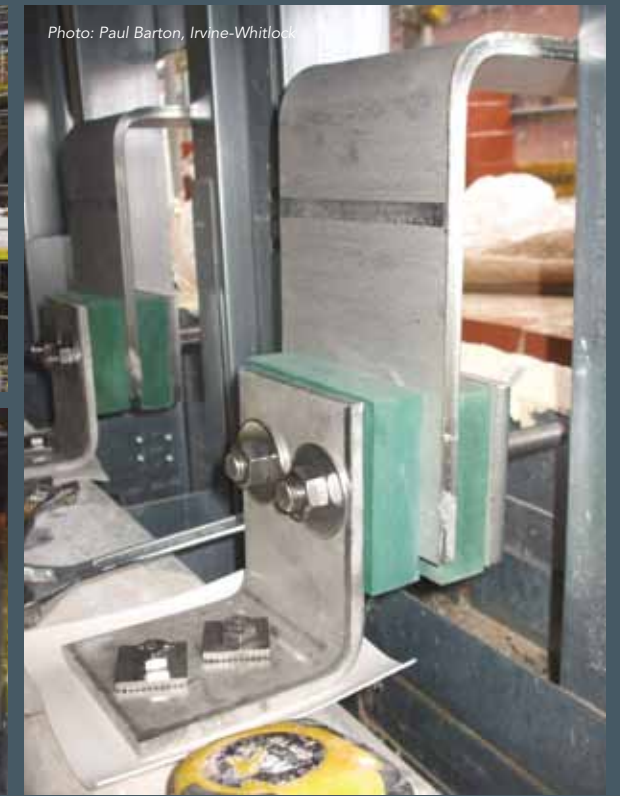
Barry Johnson says that the biggest challenge of the West Wing was acoustic separation. Initially, the ties and brackets of the West Wing's brick cladding were secured straight onto the steel frame structure. This caused the vibration from trains underneath to be conducted straight up to the bedroom areas.

Above: Acoustic separation pads had to be designed and installed between the main steel frame and the brickwork ties.

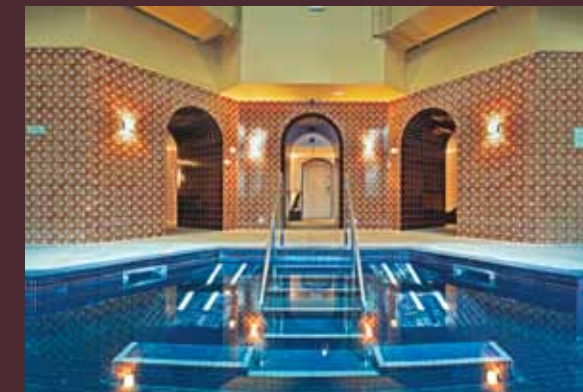
Right: Construction of the swimming pool in the basement of the listed building and finished swimming pool and spa.

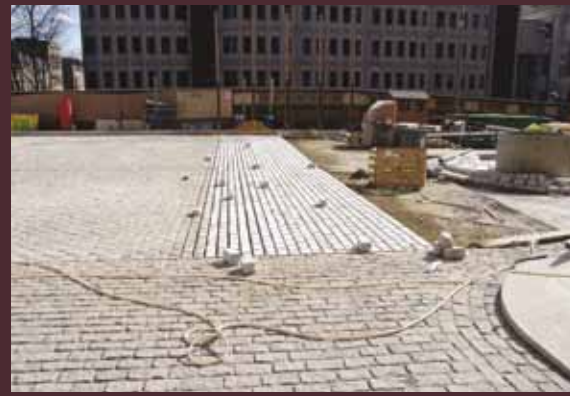
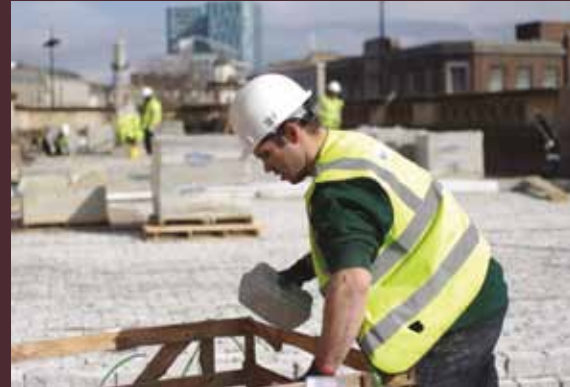
Above: 135,000 Granite setts/cobbles were imported from China. Knight Build had to organise the work to take into account the 10 week journey by sea. Knight Build kept the same personnel on all paving works, which were phased - this ensured a consistent, high quality finish.

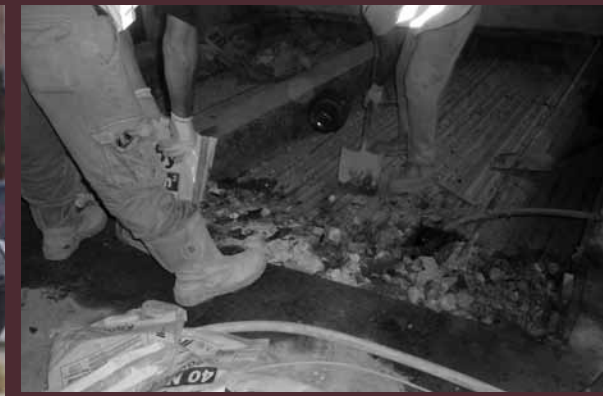
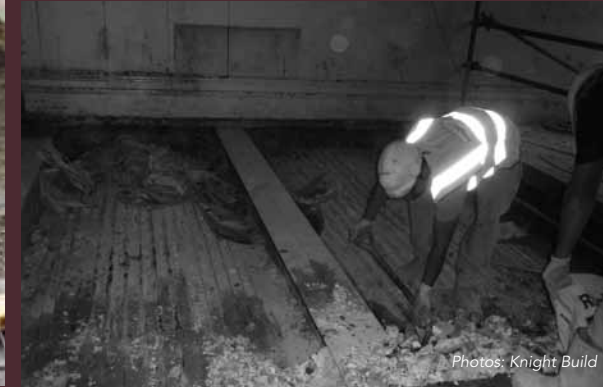
Above: The basement posed particular access and egress problems. Tiny diggers and motorised barrows were taken down and, where possible, mini cranes were situated over shafts, but large quantities of demolition rubble still had to be ‘handballed’ - ie. removed by hand!

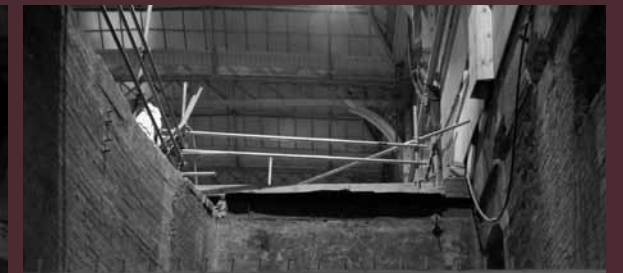
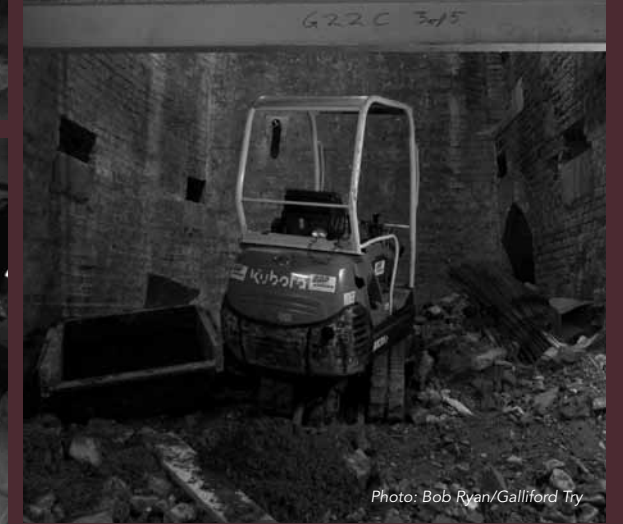
Above: Excavations in the basement were up to 6 metres deep, in very cramped conditions.

Right: Knight Build laid a total of 5,000 York stone flags, both inside the building and out. English Heritage had specified that the York stone used for paving and steps had to have a blue streak. This can be sourced at only one quarry in Yorkshire.

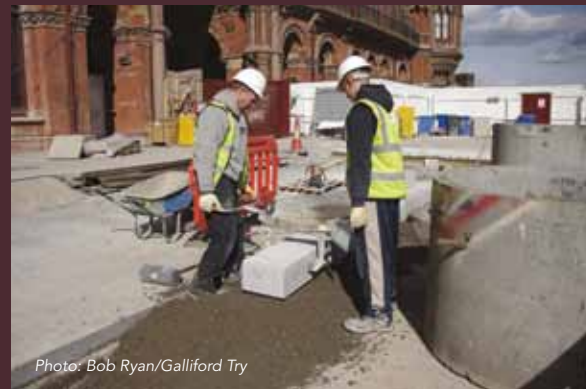
Right: Early building works on the old taxi rank, now the Hotel reception and lobby.

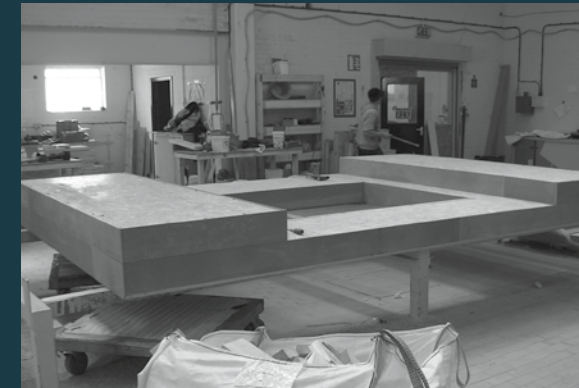
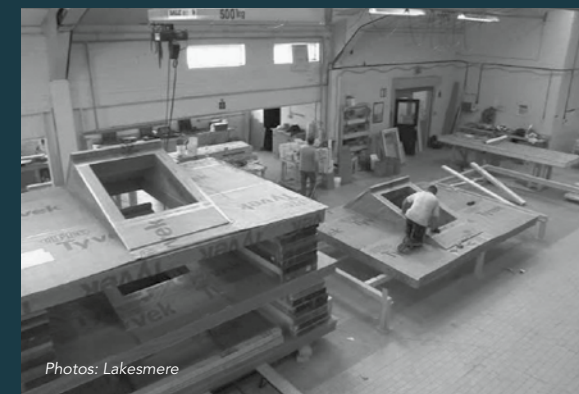
Right (both): Workshop assembly. The basic structural insulated panel (SIP) consisted of an outer frame of FSC certified timber board, assembled and injected with zero ozone depleting polyurethane foam to produce a rigid storey-height panel, 2.7 metres in length.
